**Phase IV RFI Work Plan
DuPont Belle Plant
Belle, West Virginia**

Phase IV RFI Work Plan DuPont Belle Plant Belle, West Virginia

Date: October 2012

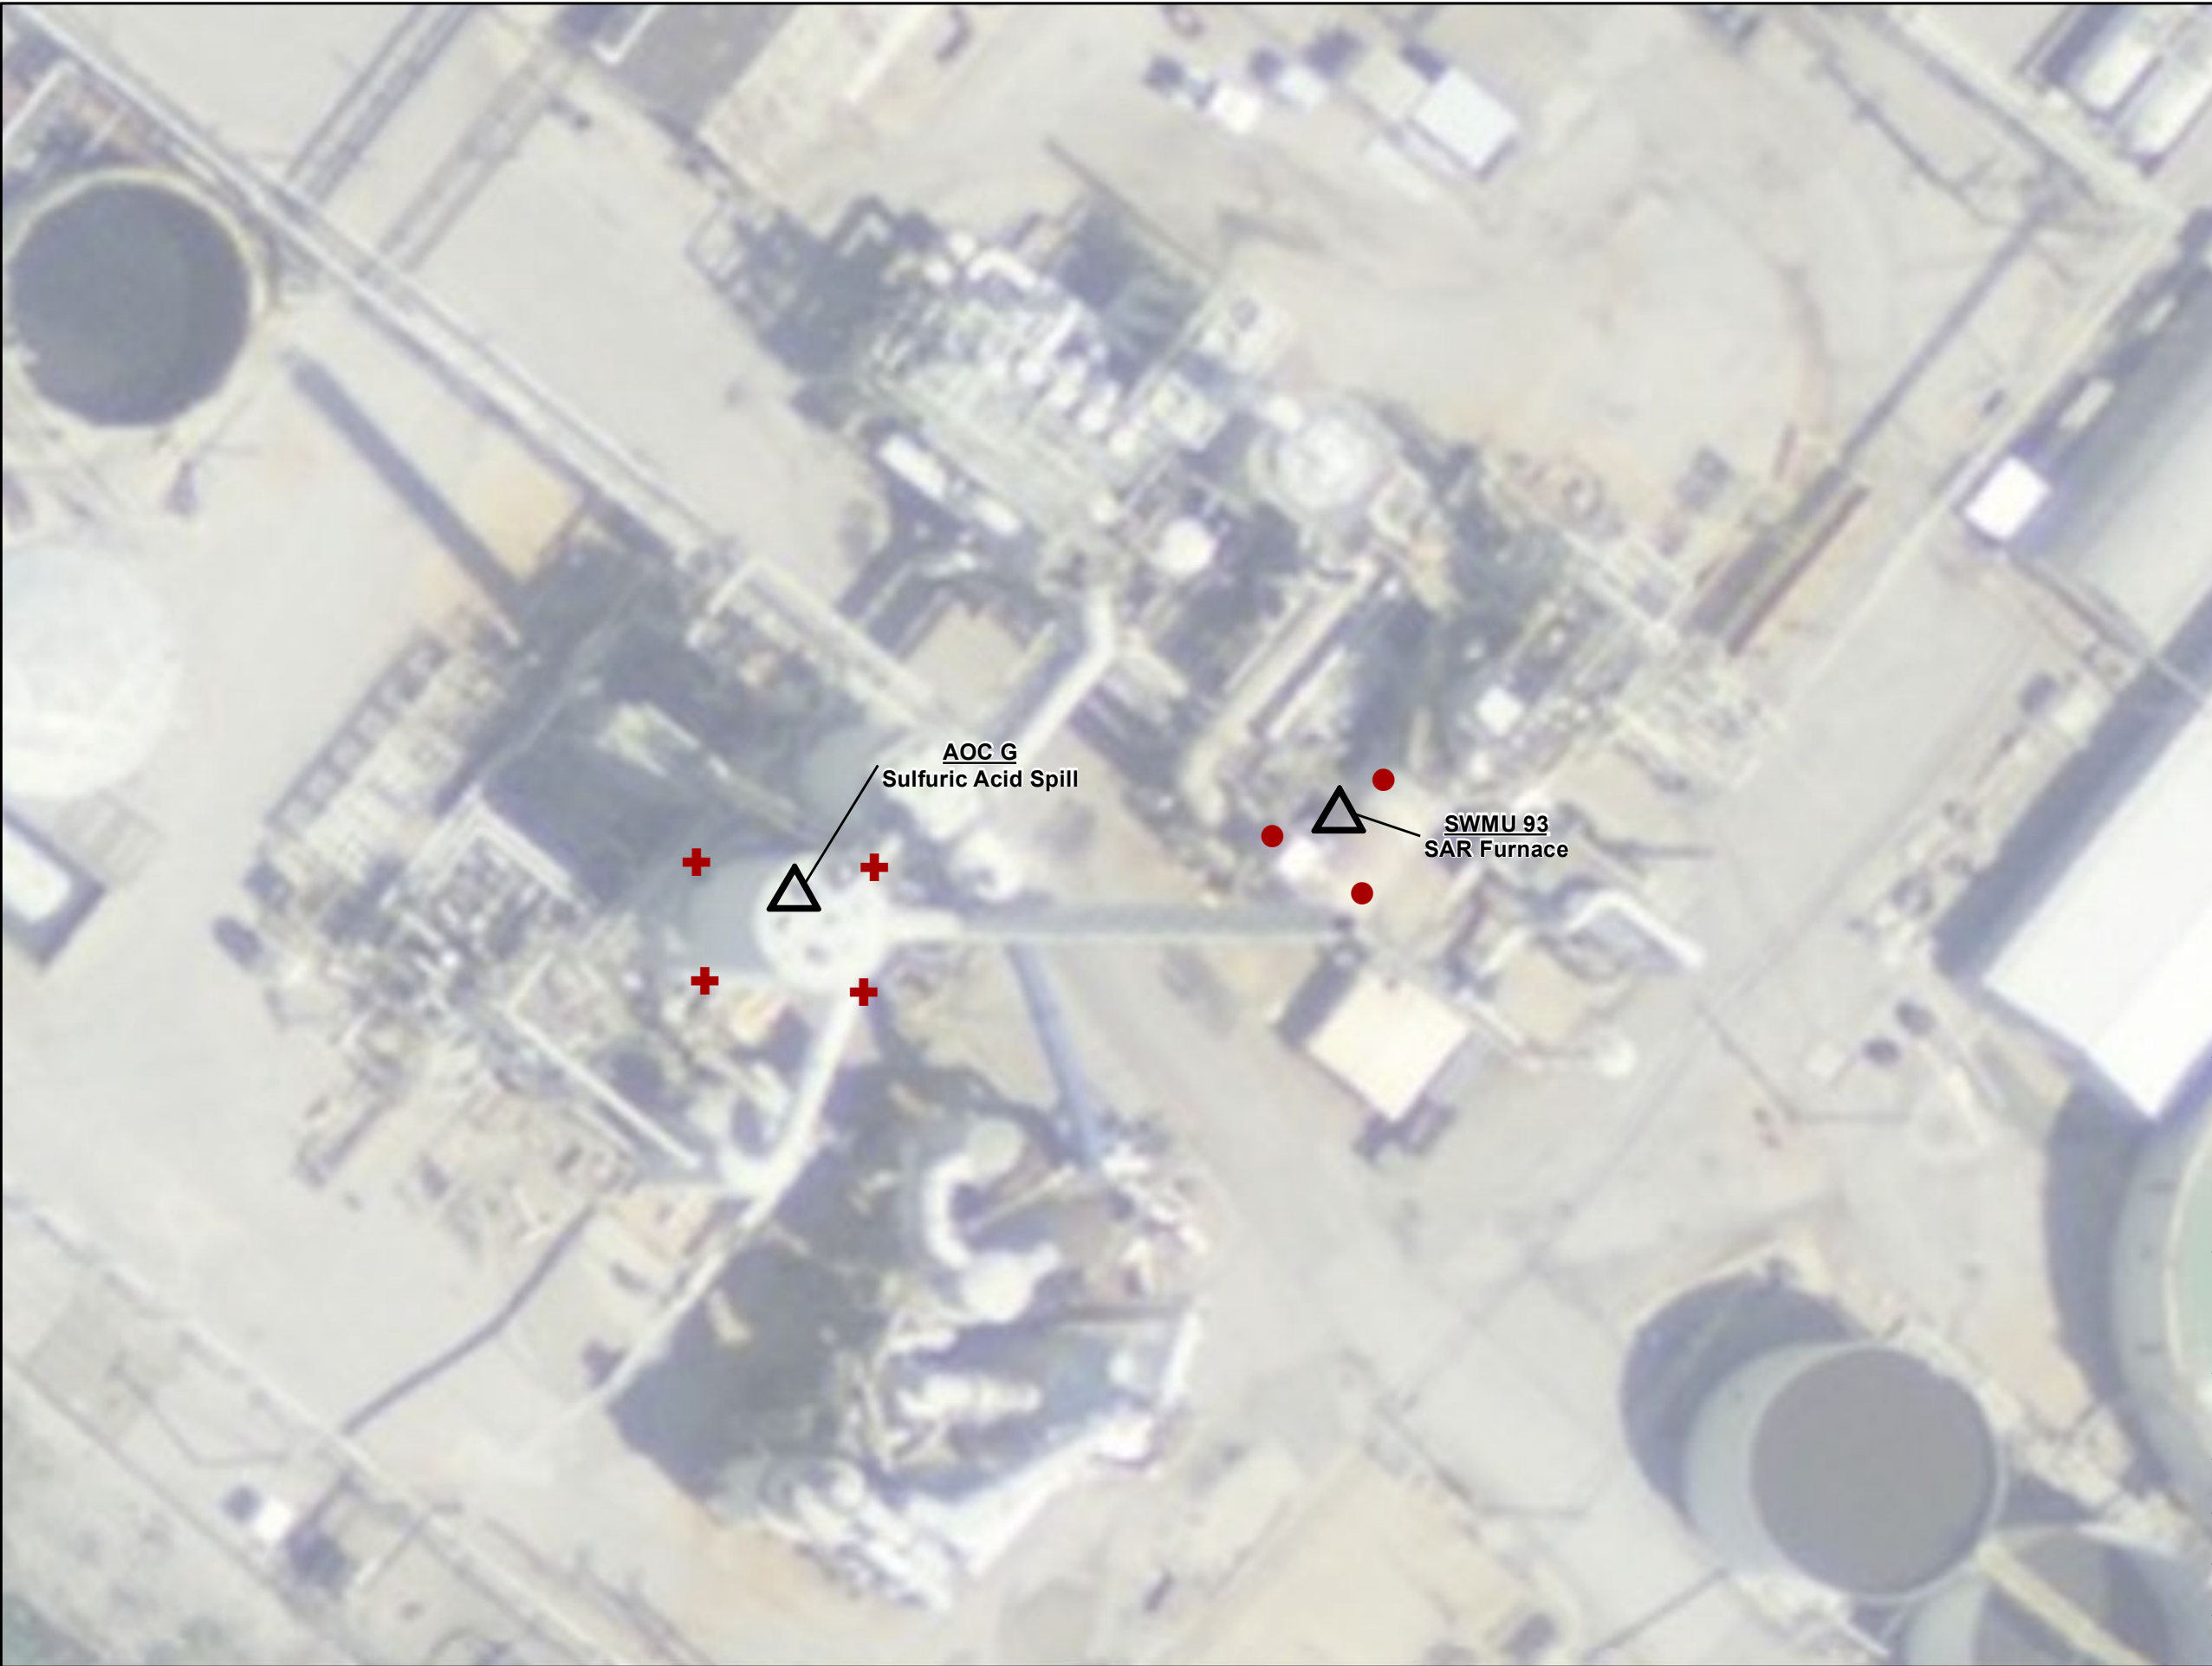
| DRAWN BY: CAA | FIGURE NUMBER: 17 |

- Legend**
- Proposed Soil Boring
 - + Proposed Surficial Soil Sample
 - △ SWMU

| SWMU/ AOC Number | SWMU/AOC Name | SWMU/AOC Description [from Current Conditions Report (1999)] | 2012 SWMU/AOC Description | Investigation Rational Based on Decision Tree Evaluation | Proposed Investigation |
|---|---|--|--|---|---|
| 93 | SAR Furnace | This RCRA-regulated unit consists of a natural gas and waste fuel-fired combustion furnace. The furnace is used to burn and decompose methacrylate, spent acid, and polymers for the recovery of sulfuric acid. | Unit is being dismantled. | <ul style="list-style-type: none"> Secondary containment may not be reliable - concrete pad only No relevant data | 3 borings VOCs SVOCs Metals Dioxins/Furan Soil pH See Figure 17 |
| AOC G | AOC G Sulfuric Acid Spill | On November 9, 1988, approximately 3,000-lb. of sulfuric acid was discharged to the Kanawha River. The spill was caused by a leak in a heat exchanger in the Spent Acid Regeneration Plant. | Unit is being dismantled. | <ul style="list-style-type: none"> Isolated spill of sulfuric acid to an asphalt area in the Spent Acid Regeneration Plant which then flowed to the Kanawha River. Soil will be investigated at the edge of the asphalt pad. | 4 surface soil samples Soil pH SVOCs Metals See Figure 17 |
